# SERVICE BULLETIN

Classification:	EM94-002	Section:	Engine Mechanical	Models:	See Below
Reference:	TECHNICAL BULLETIN NTB94-041			Date:	April 14, 1994

## BROKEN EXHAUST MANIFOLD STUD

### APPLIED MODELS: Only Those Equipped w/VG30E Engine

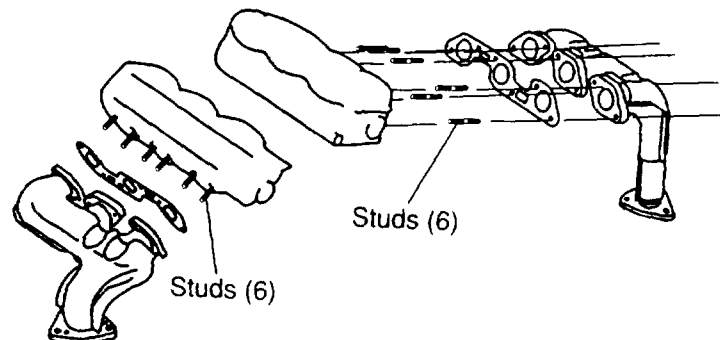
The exhaust manifold stud has been changed for improved durability. Use the following procedure to repair vehicles which exhibit excessive exhaust noise due to exhaust manifold stud breakage.

1. Remove the exhaust manifold on the side of the engine with broken stud(s). (Figure 1) For additional information, refer to the **EM** Section of the appropriate Service Manual.

2. Replace the broken stud(s) and the front and rear studs **only** using the **improved part, P/N 14065-V5003**.
3. Replace the exhaust manifold gasket and the exhaust manifold with new parts. Refer to the EM Section of the appropriate Service Manual for proper torque values for the fasteners. Refer to the Parts Catalog/Microfiche for applicable P/N's.
