SERVICE BULLETIN

Classification: BT98-027	Reference: NTB98-115	Date: February 1, 1999
-----------------------------	-------------------------	---------------------------

1987-95 PATHFINDER DRIVER'S SIDE FLOOR PAN CORROSION/PERFORATION REPAIR PROCEDURE

APPLIED VEHICLE: V6 4WD Pathfinder (WD21)
APPLIED VIN(S): ALL
APPLIED DATE(S): 1987-95

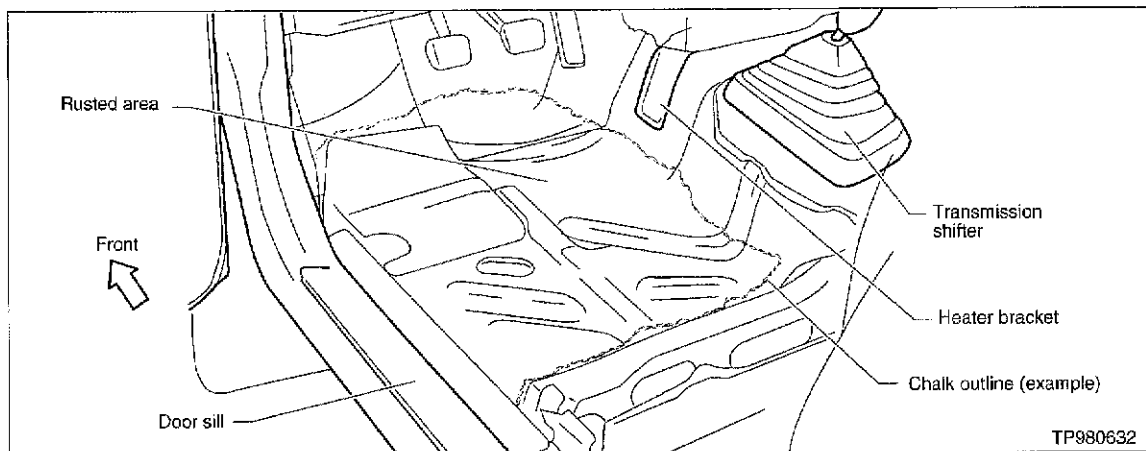
Figure 1

7. Inspect the area of corrosion. Clean all dirt, floor insulation and debris away from the area to be cut. This is necessary in order to see all the original spot welds holding the corroded section. Draw a chalk outline around the area to be removed (see Figure 1).
